CAUSE AND PREVENTION OF EXPLOSIONS INVOLVING DC CASTING OF ALUMINUM SHEET INGOT

Ray T. Richter¹, J. Martin Ekenes²

Abstract

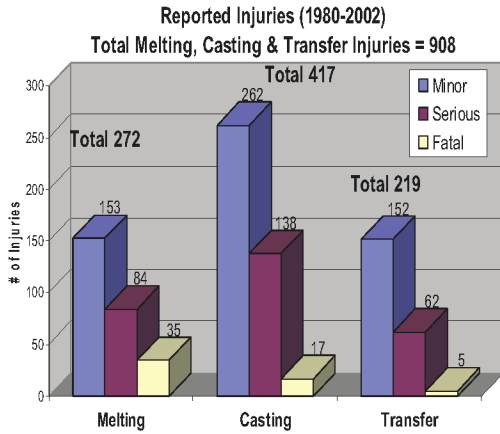
Figure 2. Injuries by Molten Metal Operation

From a health and safety perspective, the Aluminum Association data⁽²⁾ indicates a significantly higher injury rate and number of injuries for all types of casting incidents compared to melting and transferring incidents. Figure 2 shows that between 1980 and 2002 there were 417 injuries reported in casting related incidents, including 17 fatalities. This highlights the importance of understanding the nature of the hazards associated with the casting process before proposing solutions.

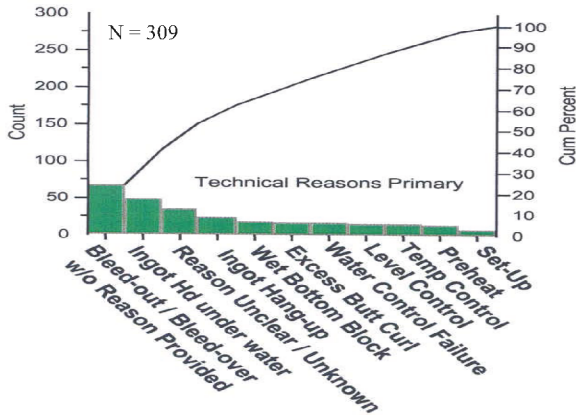
Figure 3. Reasons for Explosions - All Cast Stages

1. Of the 309 incidents involving DC casting of sheet ingot and T-bar, 240 or 78% occurred during the start-up phase. The remaining 13% and 9% occurred during steady state and termination, respectively.

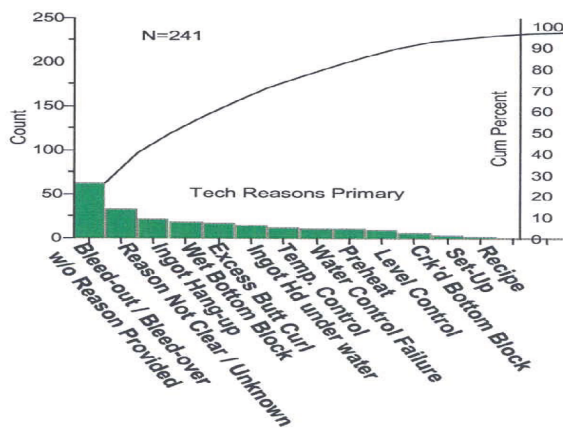
Figure 4. Reasons for Explosions - Cast Start-up

2. Of the 241 incidents occurring during the start-up phase, 60 were due to bleed-outs with no reason provided. An additional 22 had no defined reason at all. These 82 incidents resulted in 35 injuries, 10 of which were serious.

3. Ingots hanging up in the mold and excessive butt-curl accounted for an additional 54 incidents and caused 32 injuries including 7 serious and one fatality.

4. Equipment set-up, inadequate pre-heating, and wet bottom blocks were connected with 39 incidents during start-up and resulted in 33 injuries, 10 of which were serious.

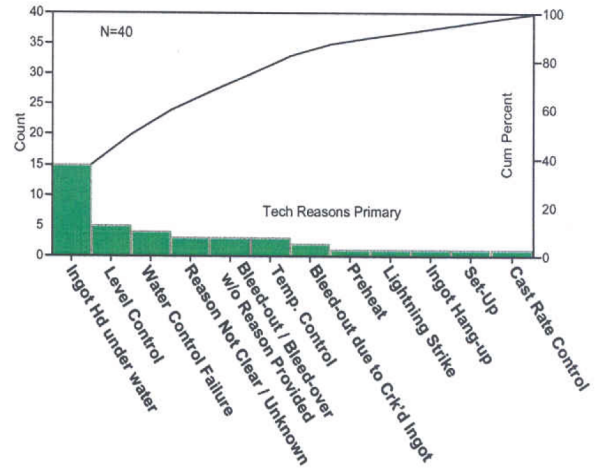
Figure 5. Reasons for Explosions - Steady-State

6. The single largest reason reported for explosions during steady state and termination was running the molten ingot heads under the water. Total number of occurrences of this was 48, 15 of which occurred during steady state, and 19 of which occurred during cast termination. Twenty-three injuries resulted.

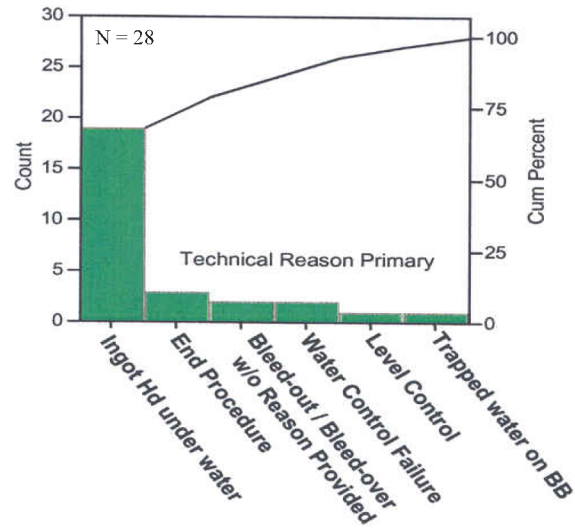
Figure 6. Reasons for Explosions - Termination

The major area of incidents during steady state and termination was running the ingot heads under water. This accounted for 15 out of 41 steady state incidents and 19 out of 28 termination incidents. It should be noted that there were also 14 of these incidents recorded during a start-up. Altogether, this area accounted for 48 of the 309 incidents, second only to “bleed-outs without reason provided.”

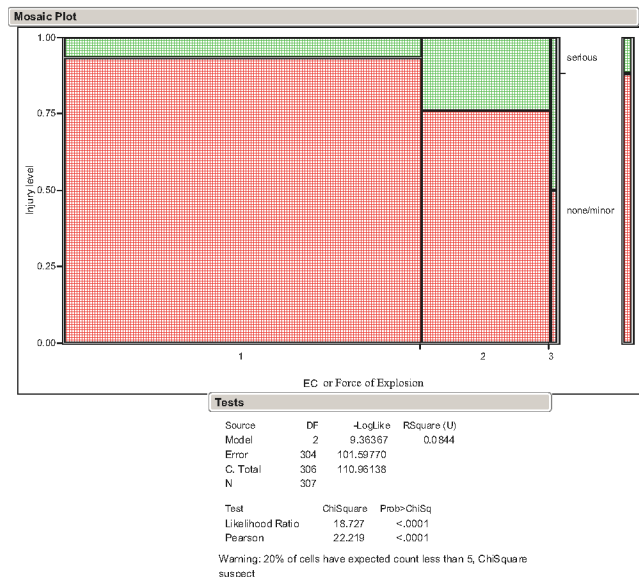
Figure 7. Injury Level vs. Force of Explosion

10. Figures 7 and 8 show that the potential for more serious injury increases with the force of the explosion (EC1, EC2 and EC3 is equivalent to Force 1, Force 2 and Force 3 in Figure 7) and the amount of metal involved with the explosion.
