CAN THE ALUMINIUM INDUSTRY LEARN FROM ANOTHER INDUSTRY'S CATASTROPHE?

Keywords: Safety Management System, Molten Aluminum Steam Explosion, Bleed out, Casthouse

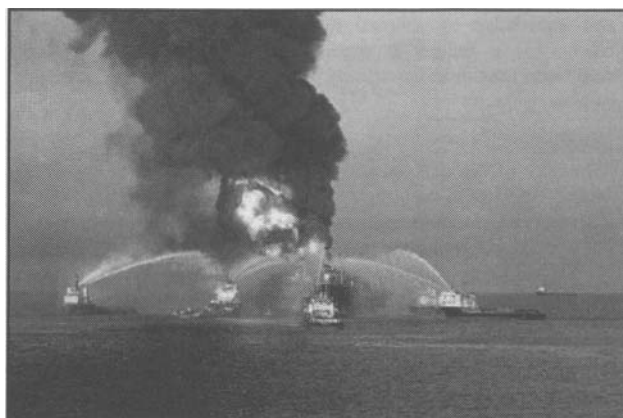
Photo 1 Deepwater Horizon Explosion in Gulf of Mexico on April 20, 2010. 11 deaths.

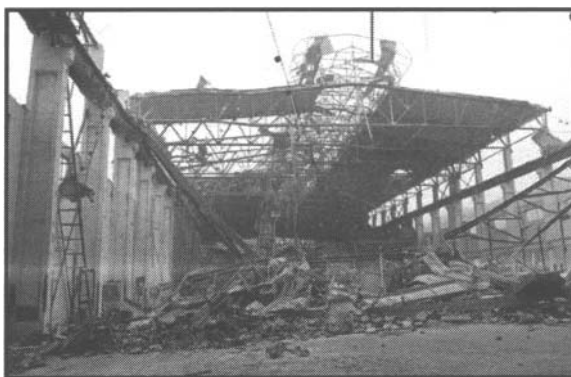
Parallels with the aluminium industry stand out when comparing the Deepwater Horizon disaster (e.g., violent explosions, damaged equipment, worker deaths and worker injuries). The list of aluminium industry catastrophes is not short: Binzhou Weiqiao Aluminum (Photo2), Reynolds Alabama, Alcan France, etc.

Photo 2 Explosion on August 20, 2007 at Binzhou Weiqiao Aluminum Company, in China. 9 workers were killed, and 64 injured.
