THE QUICK SHUT DOWN AND RESTARTING OF 291 kA PRE-BAKED POTLINE AT JSC "RUSAL SAYANOGORSK» FROM MAY TO AUGUST 2011

Victor Buzunov¹, Andrey Soldatov¹, Victor Mann², Aleksandr Pavin¹, Vasily Borisov¹, Sergey Zatepyakin¹, Evgeny Shcherbakov³, Andrey Guzenkov⁴

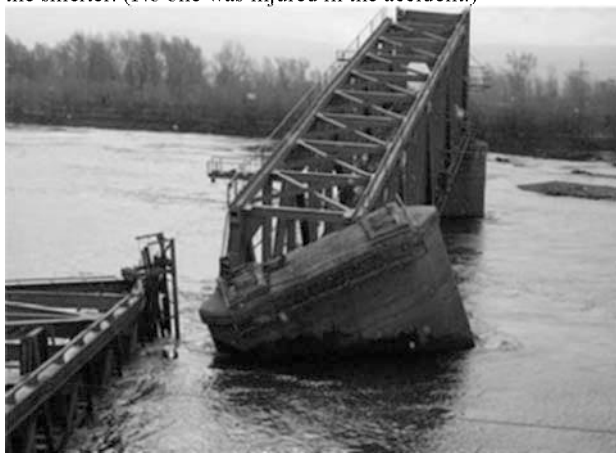
In the morning of May 7, two pillars of a railway bridge located near the Kamyshta train station (Khakass region) collapsed (Figure 1). The bridge had been used both for delivering necessary raw materials to the aluminum smelter and finished products from the smelter. (No one was injured in the accident.)

Figure 1. The collapsed bridge

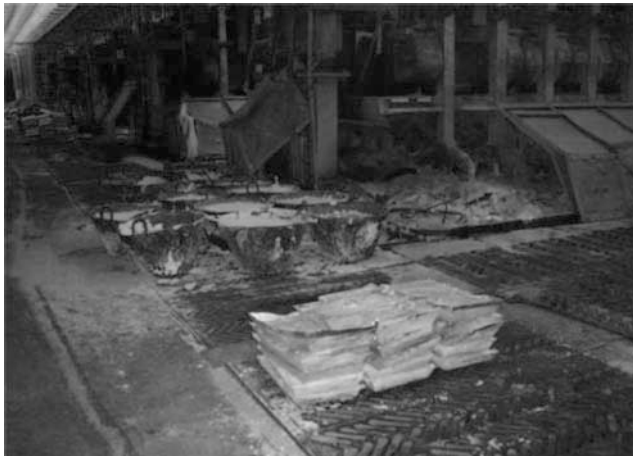
Figure 3. The shut-down cell

Then, the bath was tapped (as maximum as possible) from those cells which were not planned to be shut down (followed by short-circuiting anodes to metal.) The bath tapped was used for the cells in operation. The bath surplus was poured into special containers. The bath remained was poured into the cathode cavity of the cells shut down for relining (Figure 3).

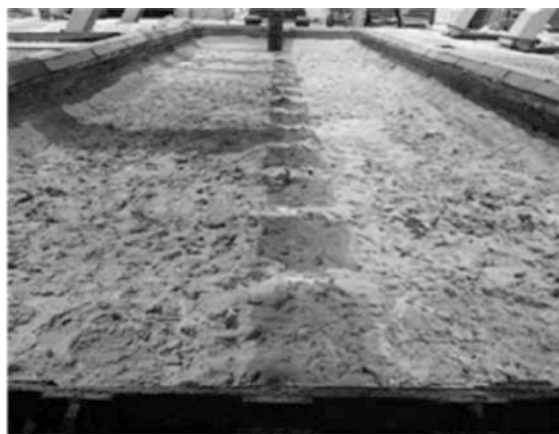
After cleaning, the cathode was inspected. A team of experts assessed the possibility of restarting the cell without relining. In those cases when patching was required, the team had to determine the scope of work to be done.

Figure 5. The cathode before the cell restart

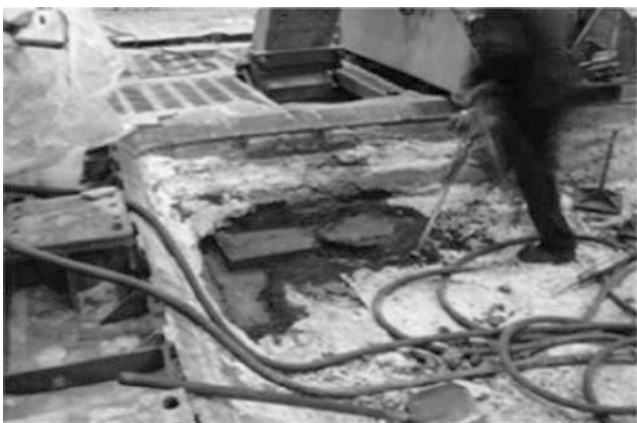
Figure 6. Bottom patching

After removing the damaged parts of the bottom, seams (up 300mm in length) were rammed by using a manual pneumatic perforator.

If damages were more than 200mm in depth and 300mm in length, fillets (inserts) cut from the bottom block were used. The length and width of the carbon fillet (insert) were 80 to 100mm less than the length and width of the defected part (Figure 6).

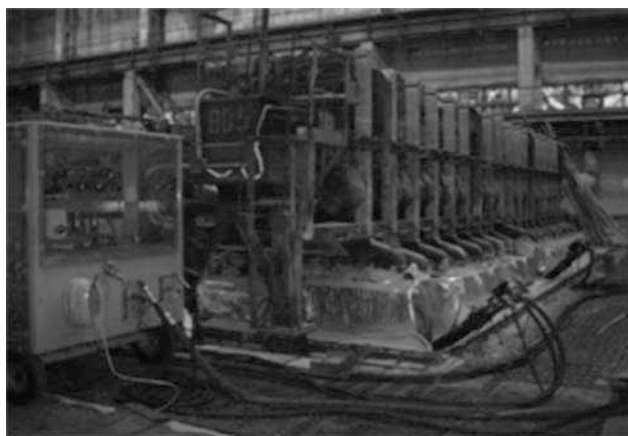
Relined cells were baked according to the current documentation used for the cell (Figure 7).

Gas preheating was deemed to be over when the temperature (according to the thermocouples used) was in a range of 580 to 900°C.

Figure 7. Cell baking

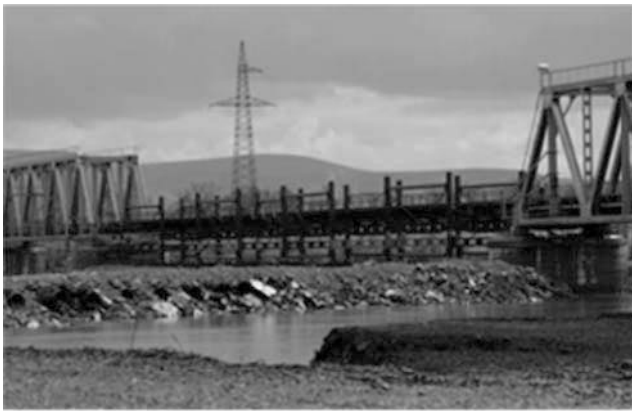
By June 6, 2011, the bridge was temporarily restored (Figure 8). Raw materials started to come to the smelter in full.

Figure 8. Temporary bridge

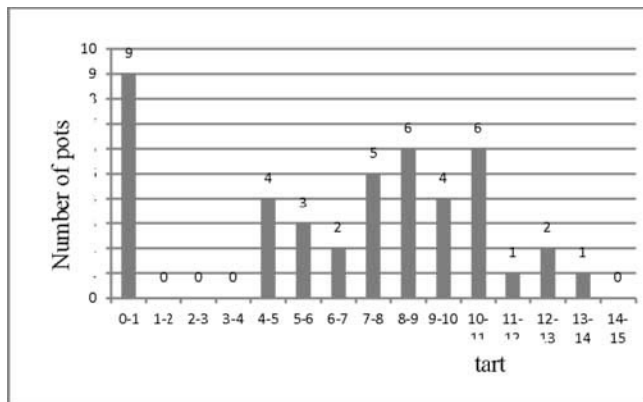
Diagram 2. The distribution of the number of shut-downs depending on the service life of the cell after the restart (as of August 31, 2012)

Nine cells (6.5 percent) were shut down right away. Their service life (after the restart) was less than 1 month. Other cells operated for at least 4 months, i.e. the restart without relining was economically successful. The average service life of the Potline 4 cells before the accident was 61.5 months. After one year of operation, it is safe to say that that the average service life of the restarted cells will be not less than 50 months.
