CORROSION OF ULTRASONIC SPOT WELDED JOINTS OF MAGNESIUM TO STEEL

Tsung-Yu Pan¹, Michael L. Santella¹

¹Oak Ridge National Laboratory, One Bethel Valley Road, PO Box 2008, Oak Ridge, TN 37831-6096, USA

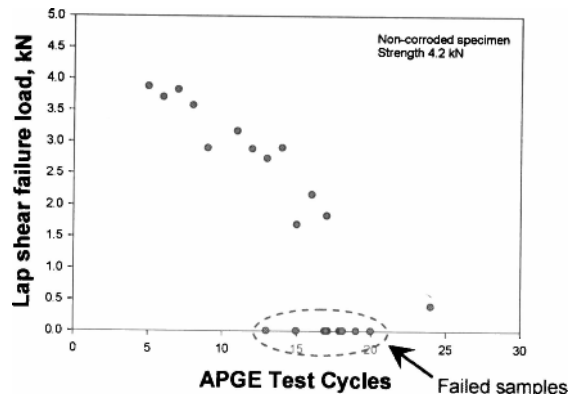
The results of the lap-shear testing are presented in Figure 1 where lap-shear strength is plotted against the cycles of exposure. The average strength of non-corroded samples was 4.2 kN [6], shown as the dash baseline in comparing the strength of corroded samples. The joint strength decreases continuously and almost linearly with number of cycles. The last surviving sample was taken out after the 24th cycle and was measured with a failure load of only 0.4 kN. Several samples separated spontaneously in the humidity chamber during the test and were not able to be measured for the strength. Joints up to 17 cycles had what could be considered practically useful strength.

Figure 1. Lap-shear joint strength of USW Mg-steel samples after cyclic corrosion test.

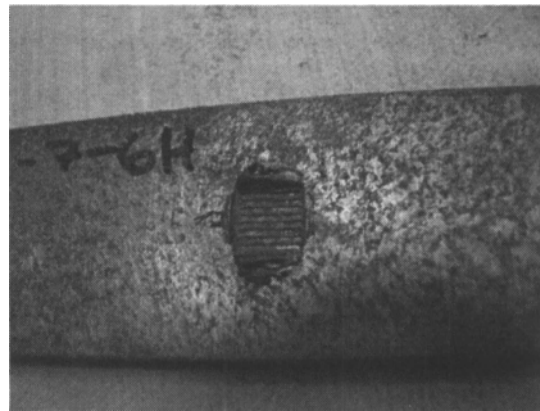
Deposits grew immediately beginning from the 1st cycle of exposure. Figure 2 shows the appearance of the AZ31 surface where deposits appeared as discrete pits. The pattern of the pits seemed related to the texture of roughness on the surface. Such deposits continued growing in subsequent cycles. After cycle 5, deposits were so dense and thick that the USW joint was hardly visible, as shown in Figure 3. The pits are similar to the pitting corrosion of Mg in aqueous solution with chloride observed by Tunold et al. [9]. They concluded that pitting was initiated by the presence of chloride ions on the metal surface.

Figure 2. Appearance of AZ31 surface after 1 cycle of corrosion test.

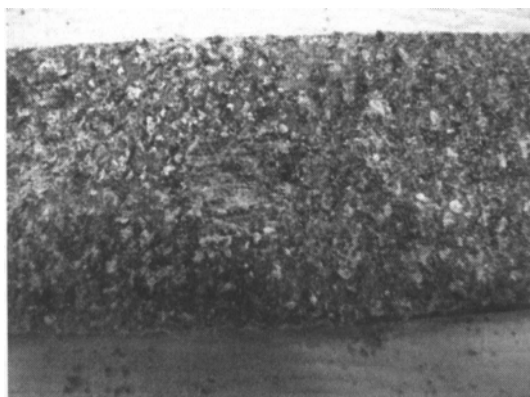
Figure 3. Appearance of AZ31 surface after 5 cycles of corrosion test.

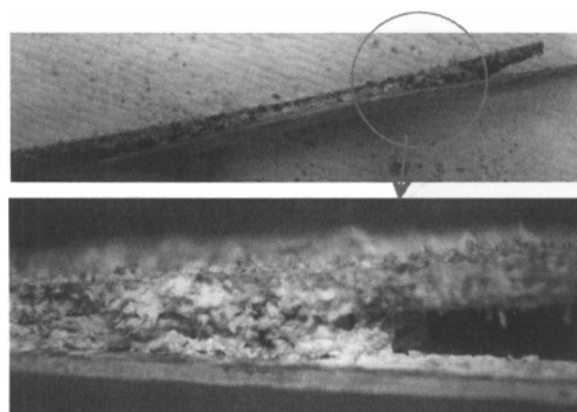
Corrosion deposits also grew in the crevices between the AZ31 and steel. Figure 4 is an optical image of the side view of the sample after 5 cycles of corrosion test, clearly showing the deposit grew in-between the AZ31 and steel sheets causing a slight opening of the joint. The deposits in the crevices grew thicker with each successive cycle of exposure. Figure 5 shows a sample after 16 cycles of test. The deposit not only grew thicker, but it also caused significant bending of the steel.

Figure 4. Oxide in the crevice between AZ31 and steel, after 5 cycles of corrosion test. AZ31 was on top.

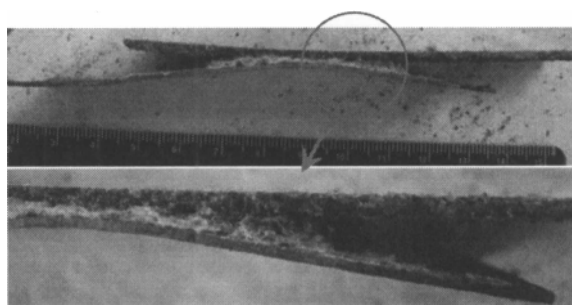
Figure 5. Oxide in the crevice between AZ31 and steel after 16 cycles of corrosion test. AZ31 was on top.

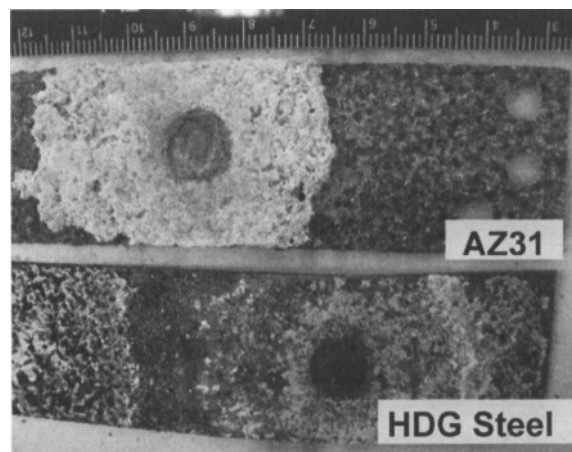
In addition to the side view of the joint sample, the deposits in the crevices could also be seen after the joints were separated either during the corrosion test or after the mechanical lap-shear test. Figure 6 shows the image of matching (inner) surfaces of the AZ31 and steel after a sample separated after 18 cycles of corrosion test. A large white piece of deposit, about 50 mm in length and across the width of the sheet (30 mm), can be seen adhering to the AZ31. However, from sample to sample, the deposit could be attached to either AZ31 or steel when the joint was separated.

Figure 6. Appearance of the matching (inner) surfaces of AZ31 and HDG steel specimens after 18 cycles of corrosion test.

In Figure 6, the surface of the deposit facing the steel sheet has a layer of ZnO, identified from the EDS analysis, indicating the consumption of the Zn HDG coating on the steel surface. As exposure cycles accumulated the Zn was progressively consumed. That led to exposure of fresh steel surface to the corrosive environment producing brown-color iron oxides.

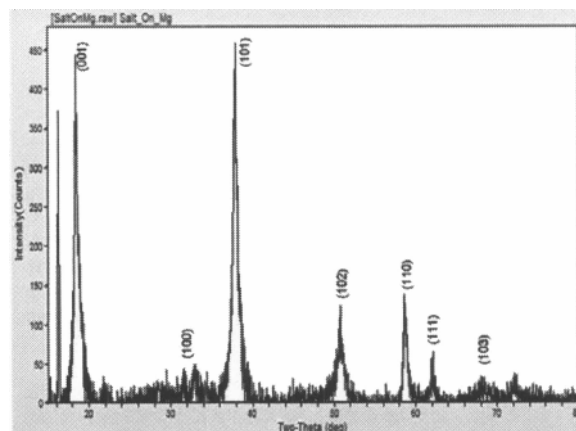
Samples of deposit were analyzed by X-ray diffraction. A representative spectrum is shown in Figure 7. Residues were identified as $Mg(OH)_2$ with major peaks matched exactly as in [10,11]. No sodium (Na) was found in the deposits.

Figure 7. X-ray diffraction analysis result of the deposit.

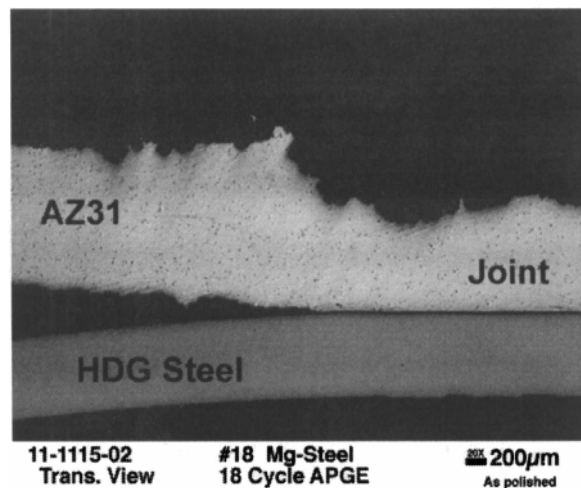
Figure 9. Optical micrograph of cross-sectioned USW after 10 cycles of corrosion test.

Figure 9 is an optical micrograph of an area showing both the joint on the right and the crevice between AZ31 and steel on the left. The corrosion in the AZ31 proceeded by pitting and occurred on both its outer and inner surfaces, as well as into the matrix of Mg. By matching the appearance of the sample before cross-sectioning, the dark circles on top of the AZ31 surface are believed to be the $Mg(OH)_2$ deposit. Similar localized corrosion was shown by Pardo et al [12] for AZ31 immersed in 3.5% NaCl solution. It was said that the $MnAl_2$ inclusions and β -phase ($Mg_{17}Al_{12}$) formed a galvanic couple with the surrounding Mg matrix which caused localized corrosion. The front of corrosion attack was stopped when it reached the lamellar aggregate of the β -phase ($Mg_{17}Al_{12}$). The existence of localized galvanic cells

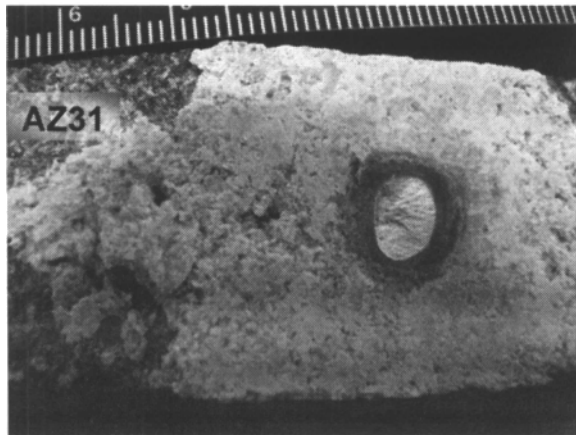
Corrosion did not occur at the welded interface between steel and AZ31. Figures 10 (a) and (b) shows the failure surfaces of AZ31 and steel sheet, respectively, following lap-shear testing sample after 14 exposure cycles. A small bump, or a nugget, can be seen on the shiny metal surface. The sample had a failure load of 2.9 kN, about 70% of the non-corroded samples (4.2kN). EDS analysis on the failure surface of this joint showed Mg on both sides of the sheets, indicating the failure occurred within the Mg material. It is also evident from Figure 9 that there was no corrosion at the welded interface.

Figure 10. Failure surface of (a) AZ31 and (b) HDG steel after lap-shear test. The sample was gone through 14 cycles of corrosion tests.
