Alumina Silica Brick Corrosion by Different Aluminium Alloys

G. Monsberger [*]¹, C. Majcenovic¹, G. Praseta²

¹RHI AG, TC Leoben, Magnesitstrasse 2, Leoben, A-8700, Austria

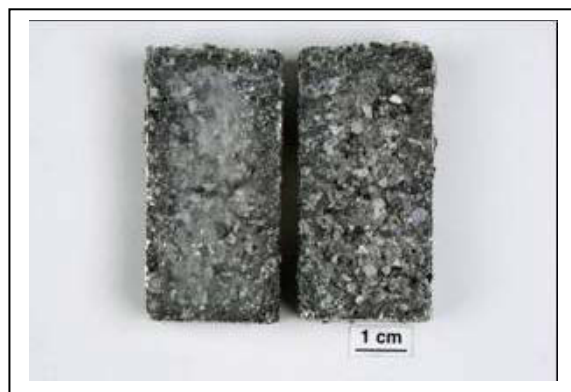
Fig.2. Bauxite brick sample cross section after testing at 850°C/ 96h. No visible infiltration & cracks

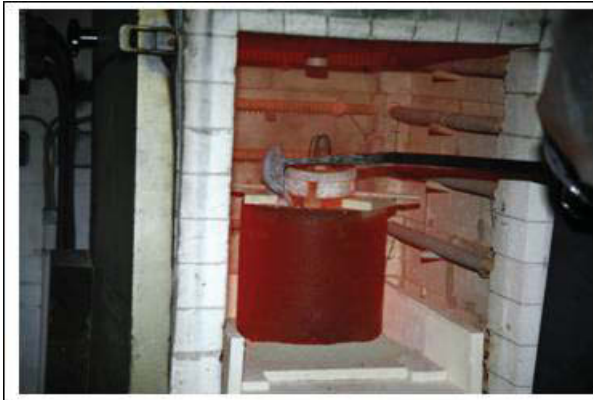
Fig.5. Silicon carbide crucible during the alkali salt input. Fig 6. Retainer with 5 fingers after 48 h. end of test

The new finger Al- immersion test is carried out in a silicon- carbide-crucible - (90%-SiC) with wall thickness 50 mm inner diameter 170 mm, depth 220 mm, total height 250 mm and a capacity of approx. 8 Kg. melted Al-alloy. This test

allows to compare at the same time 5 different specimens under two different chemical- and physical-conditions.[2] (see figure 5 &6)

Every finger with the dimensions 200 x 30 x30 mm³ is exposed to the corrosion of upstream dissolved alkalis salts (45% NaCl+ 45% KCl+10% NaF) of the transition zone as well as below the metal line where the Al-alloy bath is enriched in Mg- Zn-among other metals.

The alkalis salts with a quantity of 400 g. /10 h. have a double function, on the one hand to cover the Al-alloy bath and on the other hand impede the corundum formation in the transition zone like as in operation. [5]

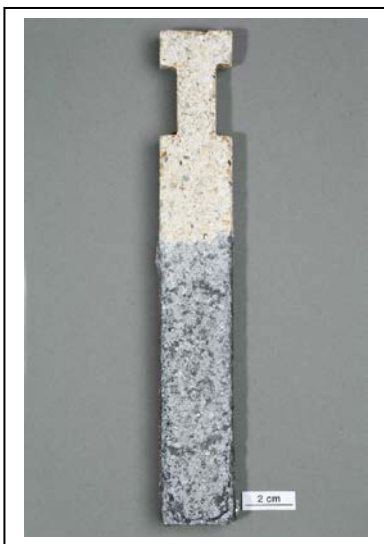
Fig.7. Bauxite brick finger after Al-immersion test

A representative bauxite brick- sample of the finger immersion test was chosen for macroscopic evaluation of the infiltration behaviours after the cut cross sections but also microscopic investigations the same sections were carried out by X- Ray diffraction and SEM. (see figures 7 and 8)
