STARTUP OF SHUT-DOWN POTS - PROBLEMS AND SOLUTIONS TO IMPROVE RESULTS

Due to the operational crisis at Votorantim Metais CBA in 2011 (VSS Soderberg technology – 128kA), some anodes were lost, consequently the cathode lifetime and conditions were compromised. With the high amount of shut-down pots, and with the need to resume production (pots in operation), a so-called “recovered cathode pot” was decided to be made, in which the pot side walls (the refractory and ramming paste layers) were cleaned, the refractory and ramp replacement for cold ramming paste was realized and, subsequently, the baking of anodes was carried out. The recovered cathode pots have different lifetimes ranging from 600 to 2700 days. Compared to the normal line pots, these pots showed high amount of leakages, premature failures and lower current efficiency. After several meetings with the technical pot room team, in May 2012 the previous process parameters were altered in order to increase the lifetime, reduce the number of the leakages and improve the current efficiency. This paper will show the implemented changes and the better results of lifetime, leakages and current efficiency to these pots.

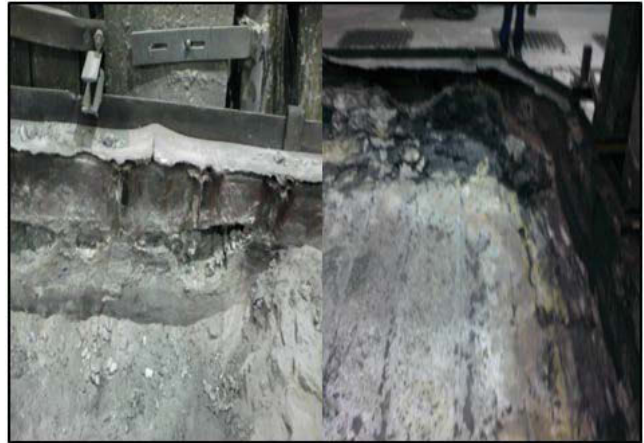
Figure 1. Cleaning

With the goal to return the production quickly, was decided to make the “recovered cathodes”, Where after removal of the anode and cathode cooling became the scraping of the blocks, cleaning of refractories and monolithic (figure 1). After cleaned, made de use of cold ramming paste to substitute the refractories and monolithic showed at the figure 2. After the conclusion of the side walls begins the pre heating, baking of the anodes, subsequently did the startup and beginning the operation of these pots.

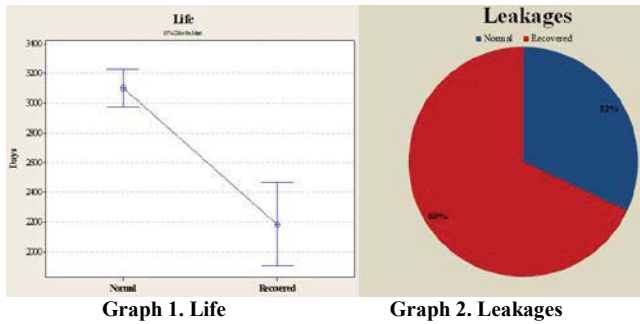
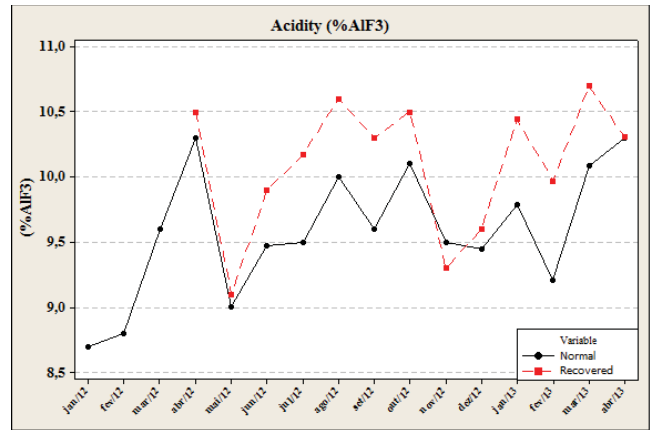
When the normal operation of these pots returned, began some problems as: early cathodes failures (graphic 1), high amount of leakages (graphic 2), lower current efficiency (graphic 3) and consequently high energy consumption.

The proper control of the temperature and acidity (%AlF₃) were essential to maintain the thermal equilibrium of this pots and consequently improve the performance thereof. The results of the acidity and temperature are shown as monthly means at graphics 4 and 5, respectively.

Graph 4. Acidity evolution (monthly means)

Graph 5. Temperature evolution

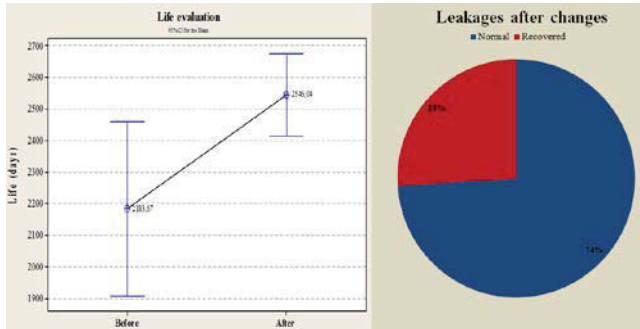
By the operation temperature reduced, seeking superheat maximum of 12°C and greater control of the side ledges of the recovered cathodes pots, the leakages reduced to percentages of 26%, showed in graphic 9. And due to greater stability and temperature control, the lifetimes of the recovered cathodes increased by 362 days (graph 8).

Graph 8. Life evaluation

Graph 9. Leakages after changes

Despite the operational difficulties encountered in the return of the operations of this pots, with the process parameters changes and greater control of this pots, the recovered cathodes pots showed better performance after the changes, obtaining a current efficiency 88,95% (0,65% higher than normal pots) and the energy consumption of 14,58kwh/tAl (0,08kwh/tAl lower than normal pots). In addition to improve the operational results, the leakages decreased for 26% of the total, increasing the average life in 362 days at the recovered cathodes.

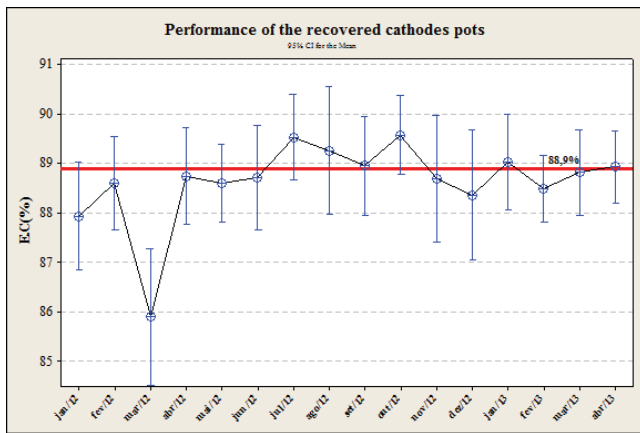
On the graphs 10 and 11, are shown the performance of the normal pots compared with the recovered cathodes pots through the current efficiency and energy consumption (graph 12).

Graph 11. Performance of the recovered cathodes pots (Current efficiency-%)
