ANODE ROD TO BEAM CONTACT

D. Molenaar and T. Kilpatrick
Commonwealth Scientific and Industrial Research Organisation (CSIRO)
Private Bag 33, Clayton (Melbourne), Victoria, Australia, 3169

Abstract

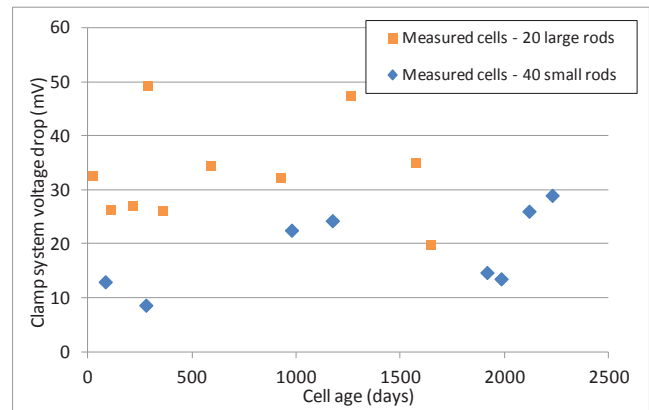
Figure 2. Clamp system voltage drop (mV) as a function of age for AP3x cells with two different anode rod configurations; 40 small or 20 large anode rods per cell.

To eliminate the effect of different reduction cell technologies, in this paper we will concentrate on the AP3x cell technology, which is a popular modern cell technology with many installations around the world. The AP3x cell technology comes in two distinct anode rod sizes and configurations, both of which have been studied here. Collection of detailed clamp voltage drop data has allowed the establishment of a practical industry benchmark by identifying the lowest typical operating points of 10 mV and 12 mV for small and large anode rod to beam configurations, respectively. Figure 2 shows the clamp system voltage drop data from four AP3x smelters; two smelters with 40 small anode rods per cell, and two smelters with 20 large anode rods per cell. Each smelter operates with a line current in the range of 355,000 – 376,000 A DC. As can be seen, the variation in the anode rod to anode beam contact performance can vary considerably between operations of the same technology, and age of the reduction cell. Figure 3 shows the clamp voltage drop data for each anode of one AP3x cell with 40 small anode rods. The data shows clamp drops from 14 – 104 mV with notable variation between left hand side (LHS) and right hand side (RHS) measurements.

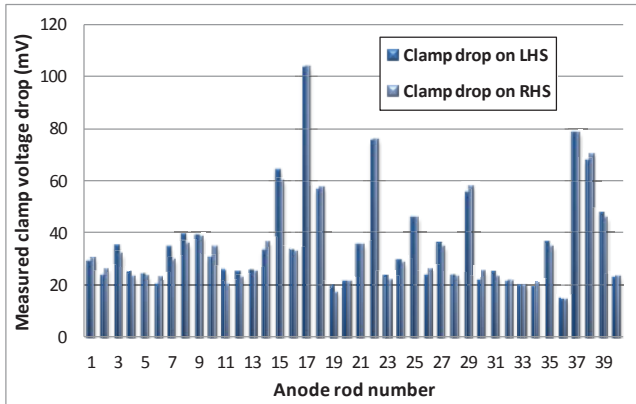
Figure 3. Raw clamp drop voltage data for the anode rod to beam connection (40 small anode rods per cell).

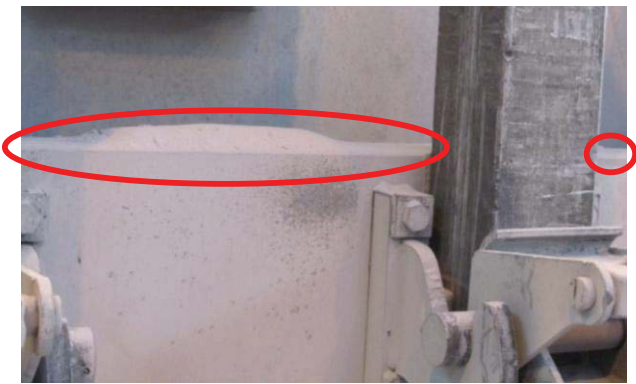
Figure 4. Anode rod clamped in place onto a reduction cell showing stray alumina on top of the anode beam.

The most observable problems associated with the anode rod to anode beam contact condition are; loss of contact surface area due to pitting, the formation of raised projections on the anode rod or anode beam contact surface and a buildup of heavy surface oxides and contamination. These are almost always a direct result of stray alumina being present on the anode beam, which makes its way into the anode rod to anode beam contact during setting and beam raising operations, Figure 4. If left unattended it can contribute in excess of an additional 35 mV to total cell voltage drop. Therefore, the elimination of the stray alumina from the anode beam should be the highest priority to minimize subsequent damage to the anode rod and anode beam contact surfaces.

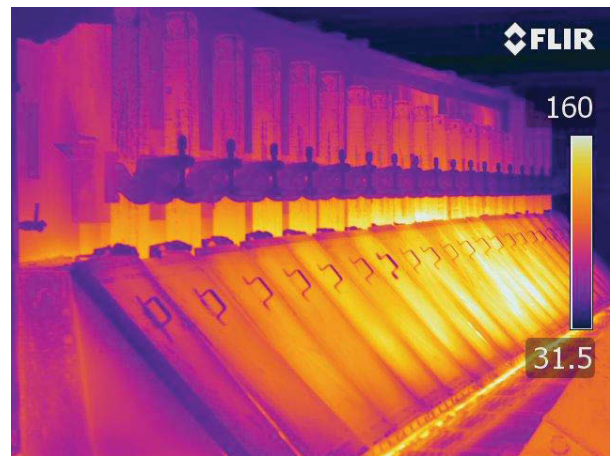
Figure 5. Thermal imaging of reduction cell showing variation of anode rod temperature across the cell.

- Stall position – will heavily influence the operating temperature and current draw of the connection. Figure 5 shows a thermal image of an AP3x reduction cell (with 40 small anode rods per cell) and Figure 6 shows the corresponding temperature data measured for both sides of the reduction cell (measured using a contact thermocouple).

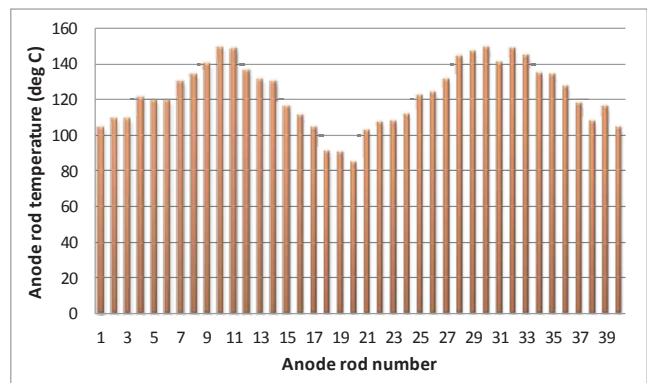
Figure 6. Recorded temperature measurement of anode rods (40 small anode rods per cell).

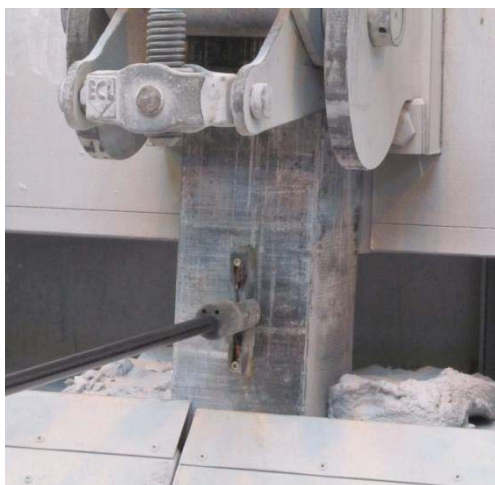
Figure 9. Anode rod current draw measurement.

drop measurements. One must also record the actual line current and ensure that the individual rod currents balance with the line current at the time of measurement. The measurement of anode rod current draw is performed as low on the rod as possible above the hood, Figure 9.

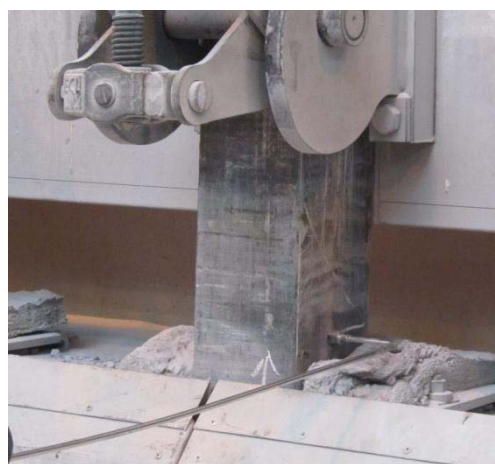
Figure 10. Temperature measurement with contact thermocouple on side of rod.

In addition to the anode rod current draw measurement, it is important to measure the temperature of the anode rod to account for changes in material resistivity. This measurement is best performed with a contact thermocouple placed on the side of the anode rod, at a height approximately mid way between the probe points used to measure the anode rod current draw, Figure 10. It has been noted by the authors, through their experience with comparing various types of temperature measurement for anode rods, that the measurement of temperature on the side of the anode rod is far more stable and indicative of actual anode rod temperature, than that measured on the front face of the anode rod.

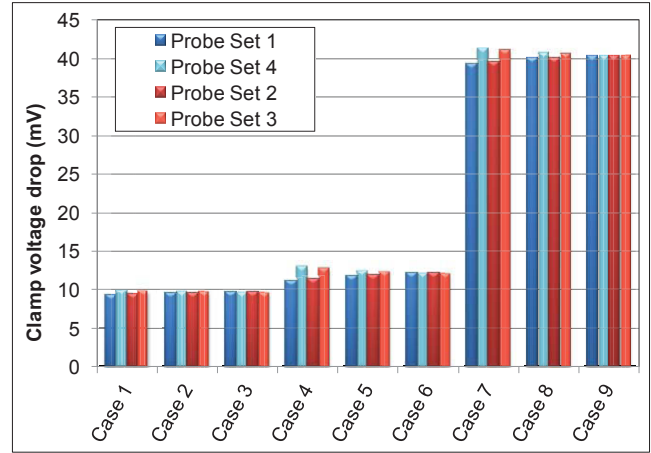
Figure 16. Clamp voltage drop for each Probe Set.

The theoretical clamp voltage drops for each Probe Set for each case are shown in Figure 16. The results show that the difference in clamp voltage drop between LHS and RHS increases (for either measurement technique) as the current input is biased towards one side of the beam, as would be expected. This is particularly evident for the larger rod configuration (Case 4 and Case 7).

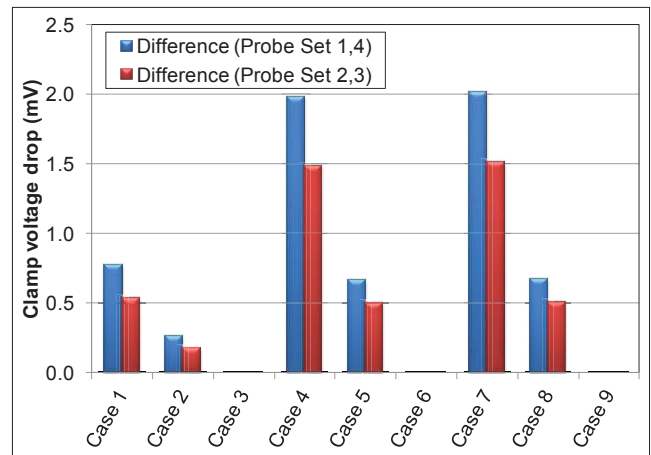
Figure 17. Difference in clamp voltage drop measurements.

Figure 17 shows the difference in voltage drop between the LHS and RHS for both techniques in more detail. Cases 3, 6 and 9 are zero because the input currents are equal on both sides of the beam. The difference in the voltage drop between the LHS and RHS not only increases as the bias in the current feed increases, but also increases for the larger anode rod configuration, Case 4 and Case 7. Interestingly, the technique measuring from front of anode rod to front of anode beam (Probe Sets 2 & 3) is less sensitive to variation in current feed than the technique measuring at a 45° angle between side of the anode rod and front of the anode beam (Probe Sets 1 & 4).

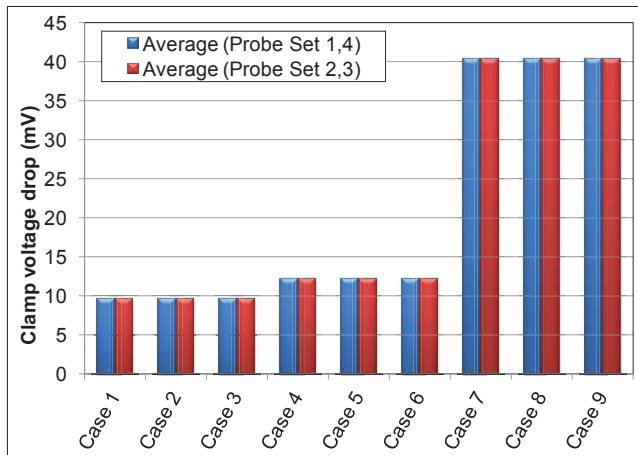
Figure 18. Averaged clamp voltage drop measurements.

An average of the LHS and RHS clamp voltage drop measurements reduces the possibility of inaccurate readings using either technique, especially if these measurements are used to gauge improvements in plant operating procedures of only a few mV. This also means that clamp drop measurements can be compared using either technique, provided you average the results as shown in Figure 18.
