PREVENTING EXPLOSIONS IN MAINTENANCE PITS UNDER FURNACES

Alex W. Lowery
Wise Chem LLC , P.O. Box 633 , New Albany , Ohio , 43054 , USA

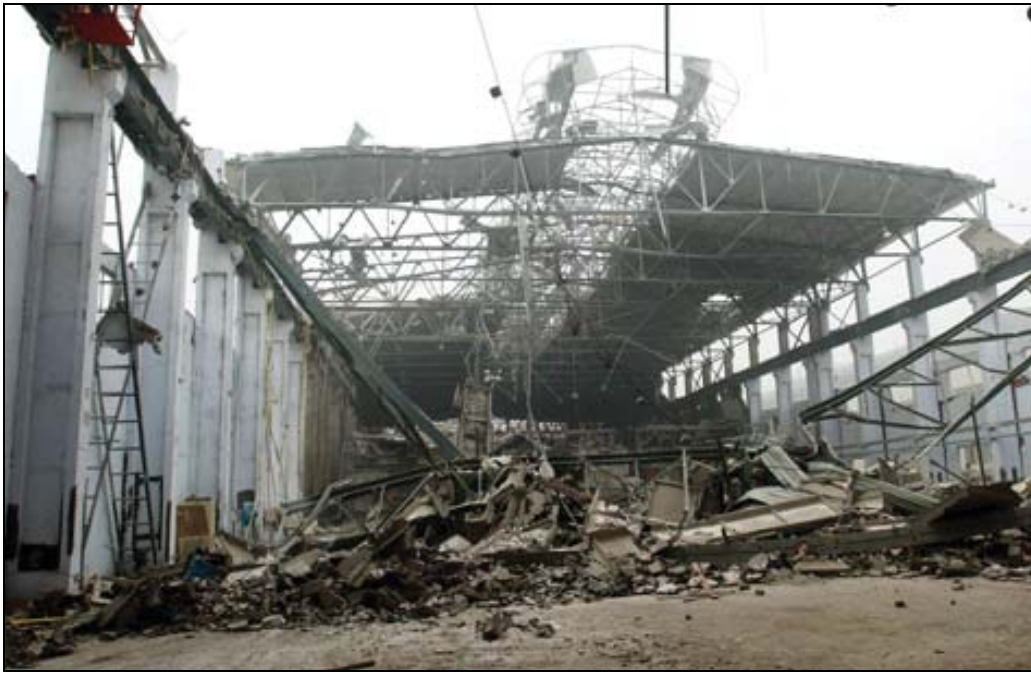
Picture 1: Force 3 explosion on August 20, 2007 at Binzhou Weiqiao Aluminum Company, in China. 9 workers were killed, and 64 injured.

Force 3 explosions are the catastrophic events arising from reaction of molten metal with oxygen from water, air or both. They are characterized by considerable property damage and metal dispersed more than 15 meters away. Often the metal has disappeared and what remains is a white powder – aluminium oxide. An example of a Force 3 explosion is shown below in Picture 1.

The most notable incident involving molten metal entering a furnace maintenance pit occurred in 2007 in China. An explosion occurred at the Binzhou Weiqiao Aluminium Company in China. Nine workers were killed and 64 injured. The report released by the Chinese Government stated a taphole in the furnace failed causing the large capacity furnace to empty its contents of over 50,000 tons of molten metal into the maintenance pit. The resulting explosion destroyed the facility (Photo 1).
