## INSPECTION TECHNIQUES FOR DIGESTION PRESSURE RELIEF SYSTEM

Gramercy Alumina, LLC, 1111 Airline Hwy., Suite 3370, Gramercy, Louisiana, 70052-3370

**Digestion Relief Header Inspection**

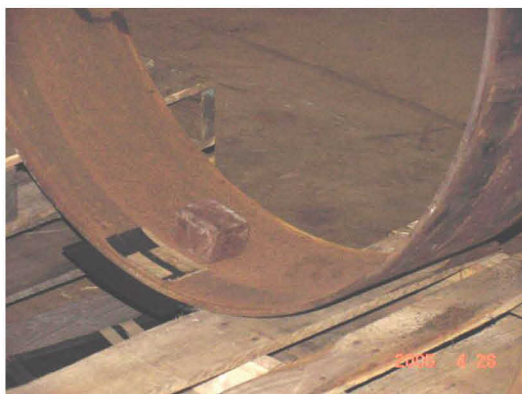
Quantifying the amount of identified scale within a pipe presented a unique challenge with radiography. Plant Maintenance Reliability personnel resolved the issue by developing standards which allowed use of a densitometer to grade radiographic film. The standards were determined by recording film densities from known scale thickness within various diameters and thickness of pipe. Test values were identified for a scale free pipe surface through 3 inch thicknesses at 1" increments. Source strength,

2" Thick Block of Scale for Radiographic Standard

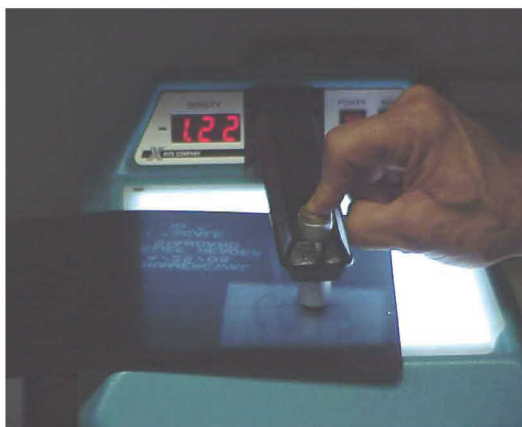
exposure time, type of film, film development chemical temperatures, and developing time were all additional variables that required control. Once the standards had been established and the nominal pipe diameter and thickness of the x-rayed site known, a technician would view the film with the densitometer. The indicated density would be compared to the standards and a scale thickness was then associated with that particular location. Tests results found no more than a one half inch accumulation of scale. The majority of radiographed sites found no scale growth.

Film Density Measurement for 10" dia. x .500" thk. Pipe with 1" Thick Scale
