USE OF CELL AUTOPSY TO DIAGNOSE POTLINING PROBLEMS

Richard Jeltsch

Richard Jeltsch Consulting, 11407 N Kathy Dr, Spokane, WA 99218 USA

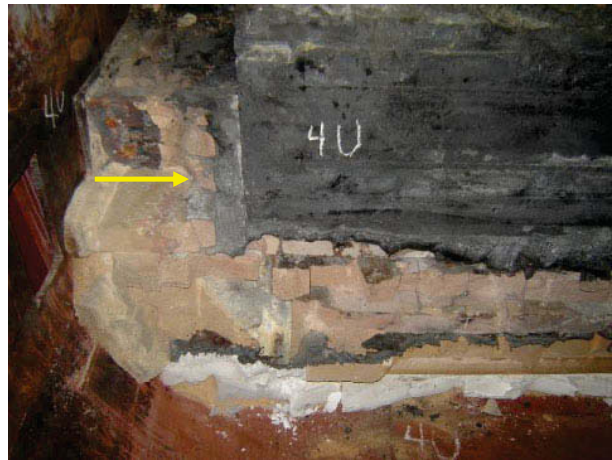
If there is too little insulation, the cell will use excess energy but, worse, the cathode block will be cooler at the bottom than at the top. This promotes arching of the block and can eventually lead to upward heaving of the cathode panel and cracking of the blocks at or near the centerline of the cell. In Figure 4 we can see the under-insulated condition in the degree of bath penetration of the refractories in the lower sidewall pier.

Figure 4. Under-insulated design. Very little bath penetration of refractories as indicated by the arrow

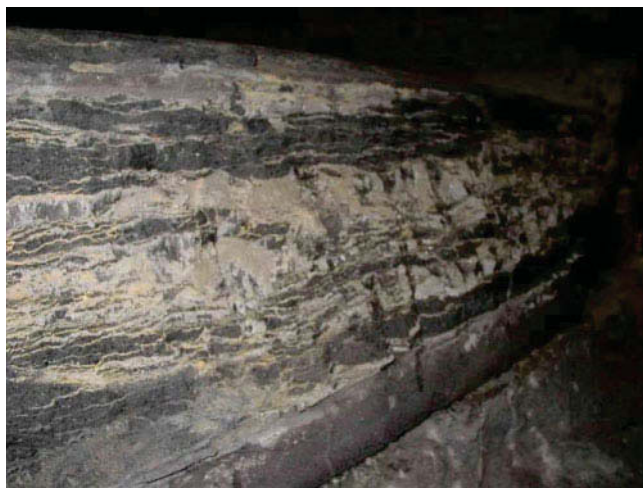
The cathode blocks shown in Figure 5 were expanded by 20 cm. (70%) due to the horizontal cracking shown. This was traced to substitution of petcoke for a portion of the anthracite in the aggregate.

Figure 5: Severely delaminated cathode block, age: 180 days

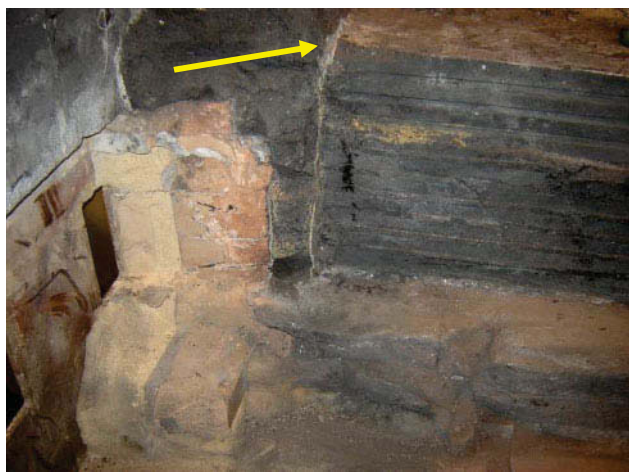
Shrinkage of ramming paste, especially at the perimeter seam, can cause leakage of metal into the lining within hours of startup of the cell as shown by the arrow in Figure 6. In this cell metal not only leaked from the collector bar holes but ran beneath the cathode blocks and into the refractories.

Figure 6: Ramming paste shrinkage in perimeter seam. Age: 28 days.

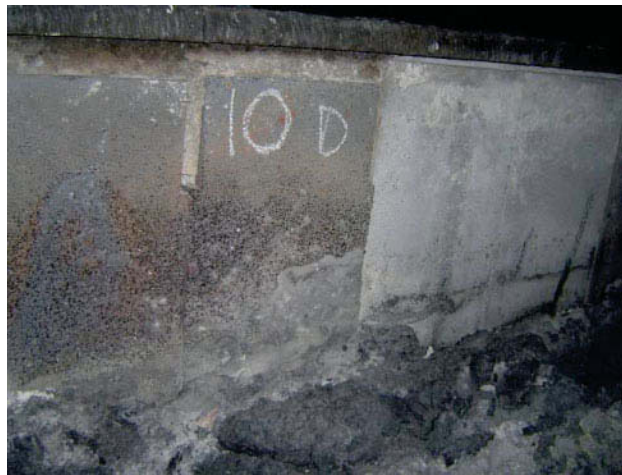
Figure 7 shows a side-by-side comparison of a proprietary bonding system for silicon carbide sidewall blocks with a standard nitride bonded block. The “proprietary” block on the left is already starting to oxidize at about 300 days.

Figure 7. Silicon carbide side-by-side test showing an inferior bonding system on the left

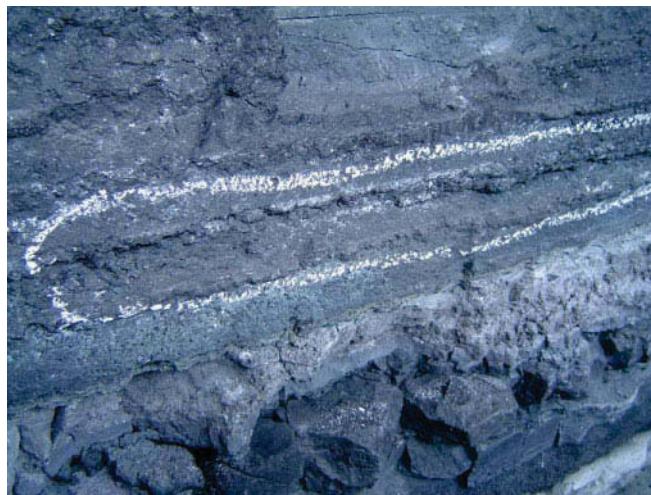
Areas of poor paste density or discontinuity between the paste layers, as seen in Figure 8, can be pathways for metal or bath penetration or develop into ratholes due to metal pad movement.

Figure 8: Rammed paste seam with poor bonding between layers seen within chalk marked area.

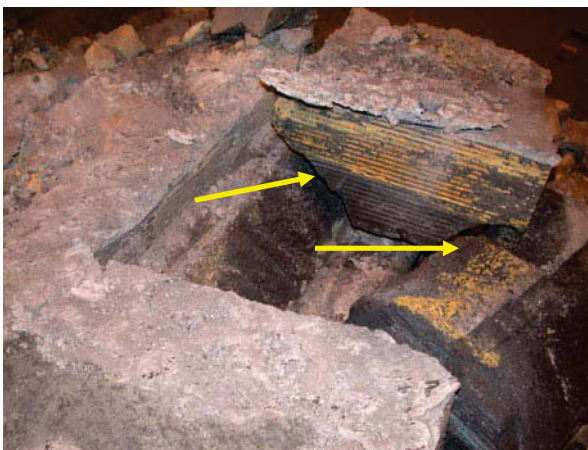
In Figure 10 we see cracks running upward from the corners of the collector bar, sometimes called “wing cracks”. In the cell pictured, this was traced to inadequate preheating of the bar and block assembly during cast iron rodding of the bars.

Figure 10: Wing cracks (indicated by arrows) caused by collector bar casting

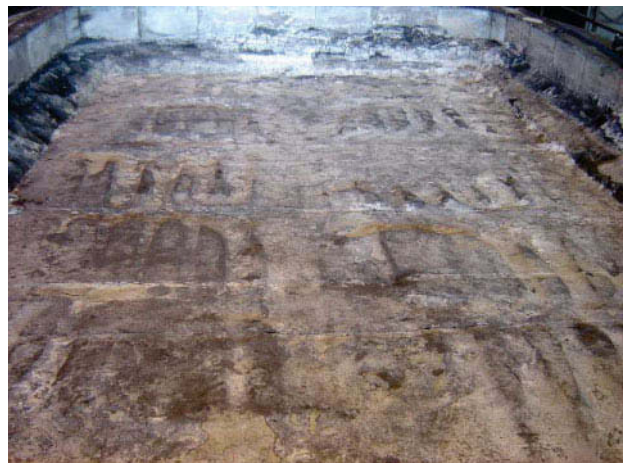
Figure 12 shows the interesting pattern seen when an electrically baked pot was stopped after 28 days. The resistor coke was laid in a pattern of narrow strips under the anode shadow. The eroded areas seen in the photo were up to 40 mm below the original surface, so before the cell was started it had already lost 15% of the thickness of the cathode blocks.

Figure 12: Surface of 28 day old pot baked with strips of coke

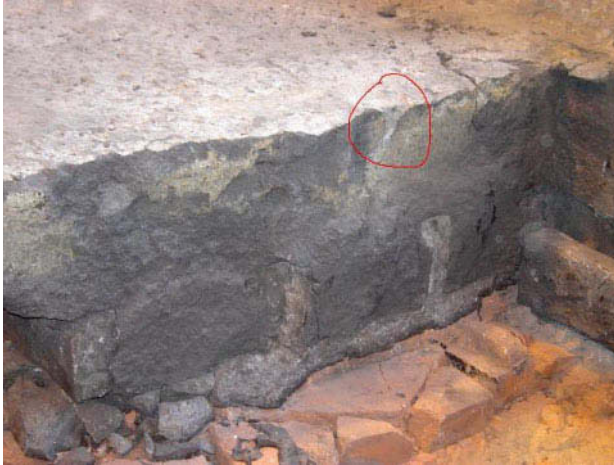
In Figure 13 we see a crack, across the center of the end cathode block and the initial development of a rathole from metal pad movement. Cells with high length to width ratio are especially susceptible to such cracking due to cumulative displacement during startup toward the ends of the cell that is not properly compensated by crushable materials.

Figure 13. Cracking of end cathode block.

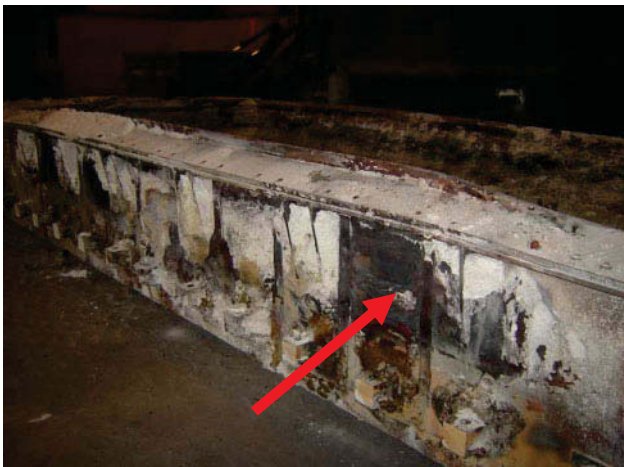
Material that is allowed to build up on the exterior of the shell will cause local overheating and distortion of the shell, eventually preventing ledge formation. Figure 14 shows an extreme example of this overheating caused by the entire trench between the cells being filled with ore and bath material. The resulting sidewall tapout is indicated by the arrow.

Figure 14: Sidewall failure due to full trenches

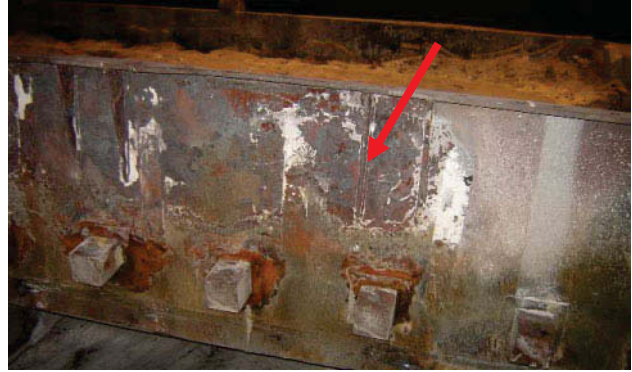
In Figure 15 we can see the overheating created when only the box created by the shell, cradles and collector bar strap was filled with ore and bath.

Figure 15: Shell distortion, shown by the arrow, from build up of material on the outside

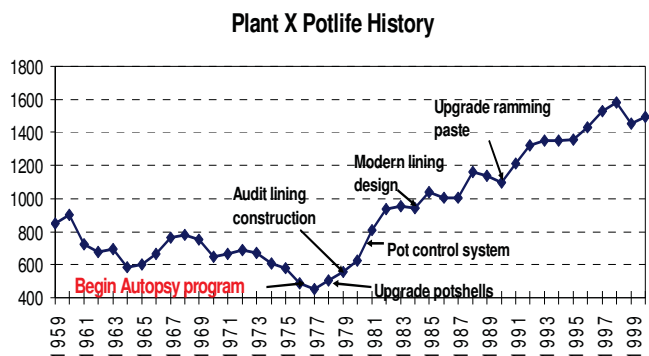
Figure 17 shows the long term results of the consistent (and persistent) application of the technique of cell autopsy to diagnose the causes of cell failure coupled with the proper program to address the issues found in the autopsies. Only a few of the most significant developments are shown. The upper bound of life for the design in this plant was about 2000 days due to an active metal pad and thin cathode blocks. The trebling of potlife in a 20 year period was a significant cost saving factor.

Figure 17: History of Potlife at Plant X
