Brazil 2001 Energy Crisis – The Albras Approach

Hânderson Penna Dias

ALBRAS - Alumínio Brasileiro S.A.; Estrada PA 483 Km 21- Vila Murucupi; Barcarena, Pará, 68447-000, Brazil

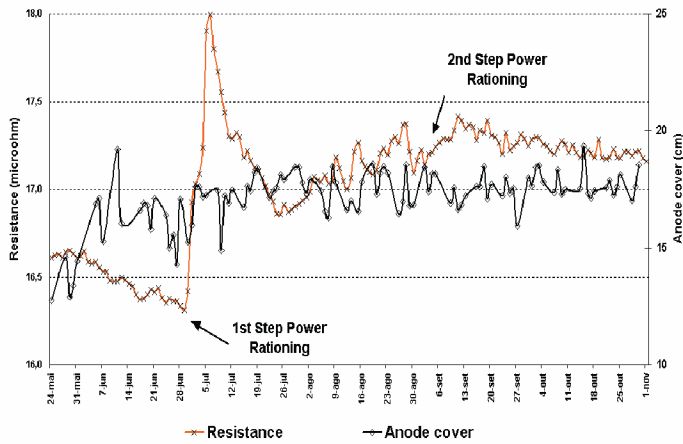
figure 1

- Increase in the anode cover (13 to 17 cm) and decrease in the pots resistance (16.8 to 16.1 $\mu\Omega$); figure 1.

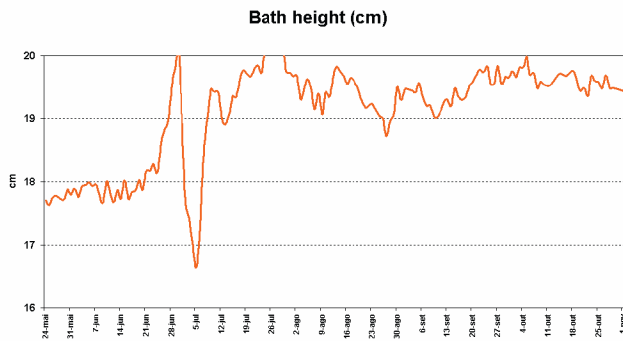
figure 2

- Increase in the bath height (18 to 20 cm); figure 2.

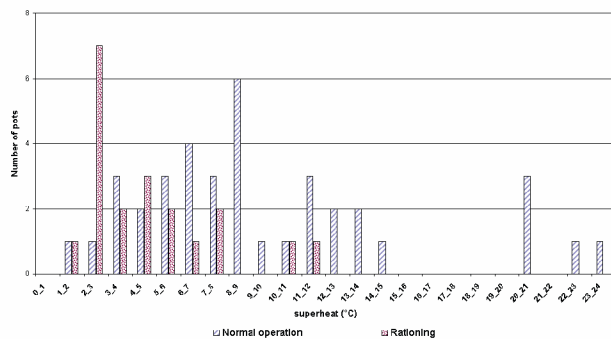
Figure 3 contains information on superheat from some Albras' pots. These measurements were made before and during the power rationing. The measurements made during the power rationing were performed after all the changes described in this paper had been implemented.

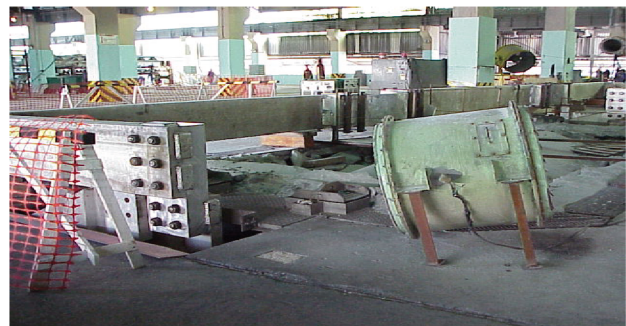
The crossover was the reason why we elected to shutdown so many pots in pot line 1. Using the crossover made possible some energy savings from the bus bar drop and we had more workers during the power rationing and for the beginning of the restart period.

Picture 1 shows the crossover used at Albras during the power rationing.

A similar strategy was used for the second step of the power rationing. The amperage was reduced from 150 to 147 kA and more pots were shutdown. Crossovers were used on pot line 1 and 3. In the end we had shutdown 120 pots in pot line 1 and 60 in pot line 3.

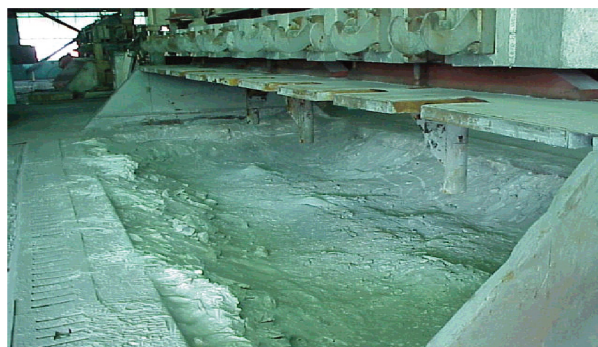
Prior to the power rationing, several types of restarts were tried and based on this work the pots were shutdown with some bath left in them. The amount of bath that was left was enough to protect the cathode blocks during cooling while also being little enough to allow easy cleaning of the pot for the restart period.

Picture 2 shows a typical cathode block situation after shutdown.

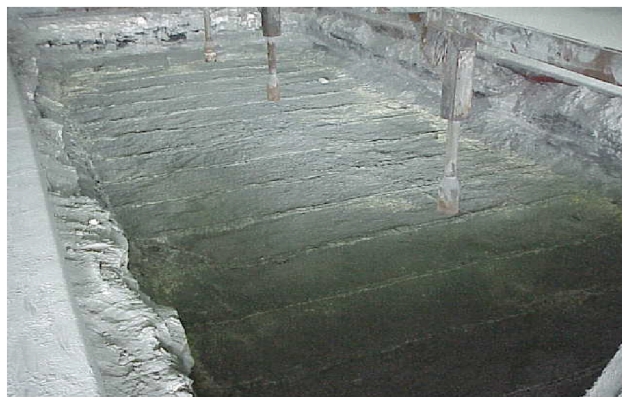
Picture 3

It should be noted that even after leaving some bath in the pot to protect the lining, oxidation still occurred (as can be seen in Picture 3).

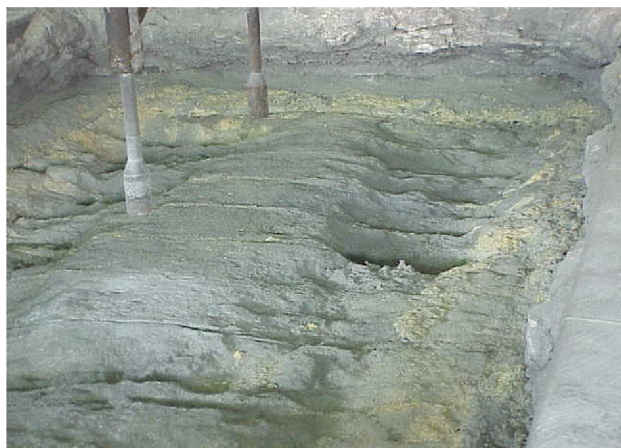
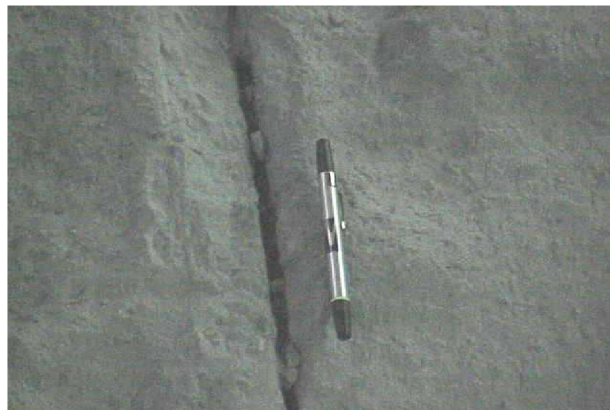
The cathode block conditions of some pots that were restarted can be seen in the pictures 4 and 5.

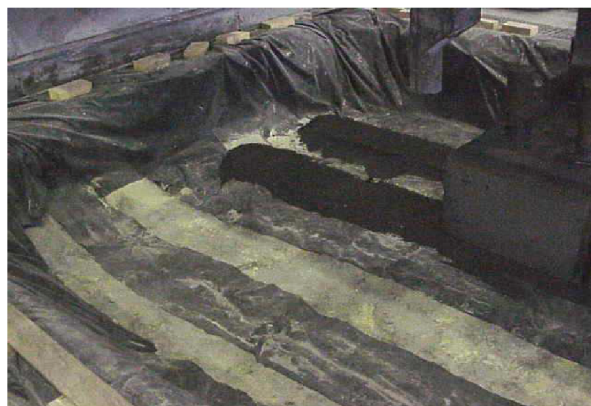
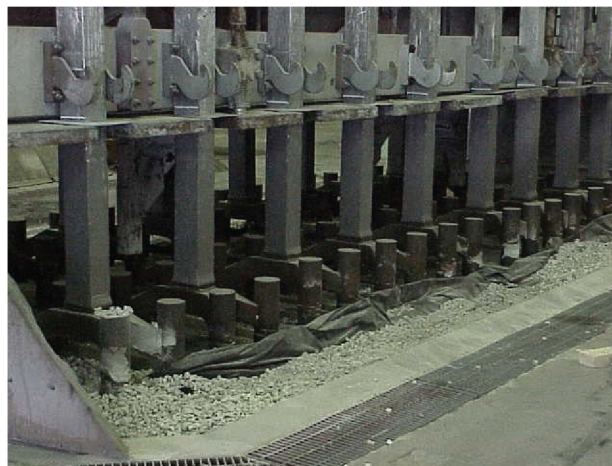
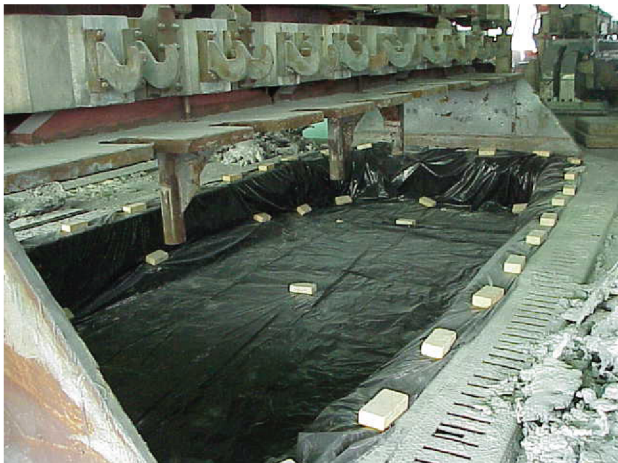
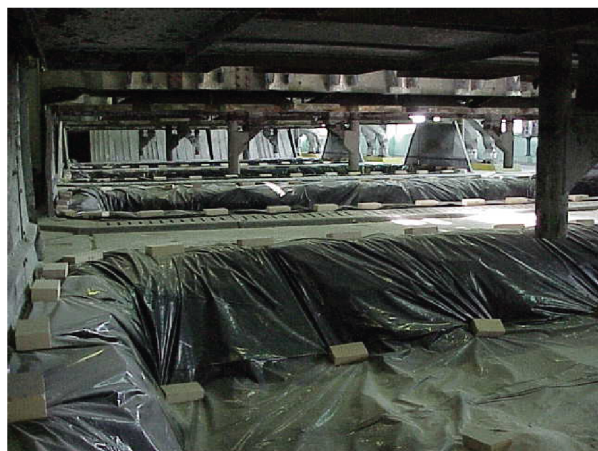
The pots were cleaned and then prepared for the restart, as seen in pictures 6 and 7. This cleaning had to be done sometime before the restart due to the large number of pots being restarted. Immediately following the cleaning, plastic sheet was placed over the cathode and sidewalls for protection, as seen in pictures 7, 8 and 9.
