## THE RESTART OF TWO IDLED POT LINES AT ORMET PRIMARY ALUMINUM

Cecil Smith, Mark Christman  
Ormet Primary Aluminum Corporation P.O. Box 176 / 43840 St. Rt. 7 Hannibal, OH 43931

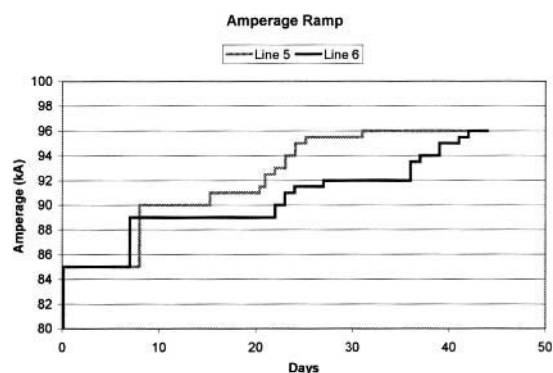
Figure 3. Amperage ramp for lines 5 and 6 from the initial start dates

The rectifier operation and personnel associated with the rectifier were also major reasons for the successful restart. The rectifier systems at Ormet vary from line to line and each has different capabilities. A big reason for the differences is due to the different construction times on the lines. Line 5 was constructed in 1957 with GE half-wave rectification technology used in the rectifier. Line 6 was constructed in the 1960's with full-wave rectification employing Westinghouse, Alstom and Fuji technology. For the restart the rectifier needed 150V initially, which required the electrical resistor bake of 32 pots. This was done using only pots on the West end of the line while using a crossover bus to keep the East end isolated. The amperage was kept to 50 kA for the initial hour and gradually increased to 80 kA throughout the first 8 hours of the re-start. This was done to allow the bus work and all the connections to come up to temperature. As the voltage of the bake pots fell off more resistance was needed on the pot line and was supplied via crash restart pots. The crash restart pots were brought on from a cold state, but had been in operation prior to the shutdown. The crash restarts supplied up to 50V of demand power per pot and because of the configuration of the lines it was possible to do two restarts at a time, one in each room. This allowed the rectifier to stay within a 100-volt range, which was required due to the use of a "no load" transformer. Each step on the transformer was worth 100 volts, but as the name implies the load had to be taken down in order to step up the voltage. These steps were coordinated with the pot rooms in order to minimize down time by taking the step up when the load was dropped to bring on crash restarts. Normally about 14 pots could be restarted between steps depending on how fast the voltage was reduced after the initial bath up.
