Cathode performance evaluation at Votorantim Metais – CBA

Jean C. Pardo, Paulo da Silva Pontes, Thiago Finotti, Alexandre M. P. Lima
VM-CBA (Votorantim Metais – CBA); Moraes do Rego, 347; Alumínio, SP 18125.000, Brazil

In this paper, the main findings extracted from pot autopsies will be presented as an important methodology to maximize cathode life at Votorantim Metais (CBA).

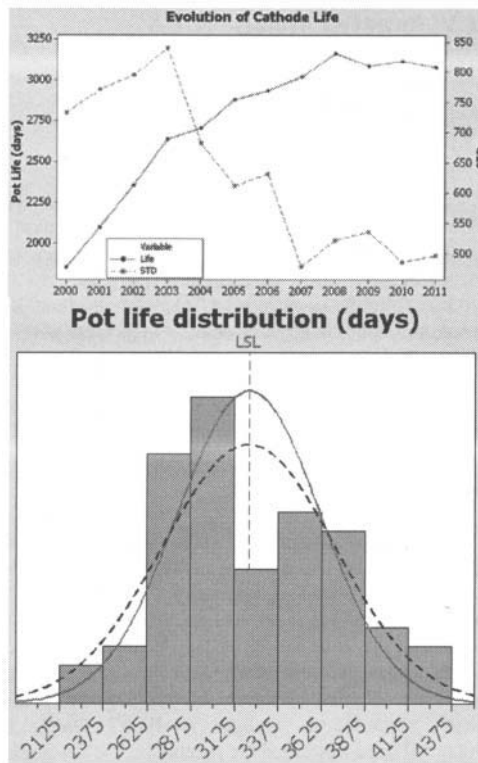
Figure 1. Cathode life evolution and its distribution

The cathode average life at VM-CBA is presented in Figure 1. This increase on average life is related to gradually change of the cathode from semi-graphitic to graphitic blocks also the whole lining materials was changed. These modifications were necessary to allow pots to operate at higher load (from 115kA to 130kA). At this moment, potlines are operating closer to the final target, in a range of 125 to 128kA.

The pot life average in 2010 was 3210 days and the main reason for the shutdown was Iron contamination and the high energy consumption due the increase of the cathode voltage drop (CVD).

According to Figure 1 about 50% of pot life is lower than the 3210 days, it implies in production losses and increase in costs.

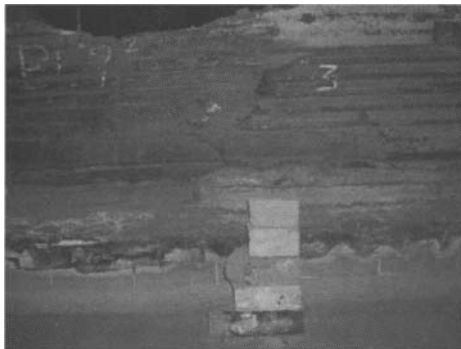
Figure 5. Dislocation of bottom lining up to 117mm.

An inspection on the bottom of cathode showed an intense transformation of silicon-alumina bricks. As known this is related to the "Sodium Swelling" that implies in an expansion of these bricks, this phenomena rises the cathode blocks up to 117 mm when compared with the standard project.

The phase formed in the equation 2 and 3 promotes a volumetric expansion up to 16% and 23% respectively, in instance part of the dislocation of cathode blocks could be explained by these phenomena. This volumetric expansion is showed in figure 5.

To minimize the impacts of the “Sodium Swelling” on the refractory and insulating assembly some actions were developed as follow:

- Cup Test as a control parameter to evaluate the performance among different suppliers;
- Increasing the pre-heating temperature for pot start-up from 680°C to 880°C in average.
