## TRUTHS AND FALSEHOODS OF MOLTEN METAL EXPLOSIONS IN THE ALUMINIUM INDUSTRY

Alex W. Lowery

Wise Chem LLC; P.O. Box 633; New Albany, OH 43054, USA

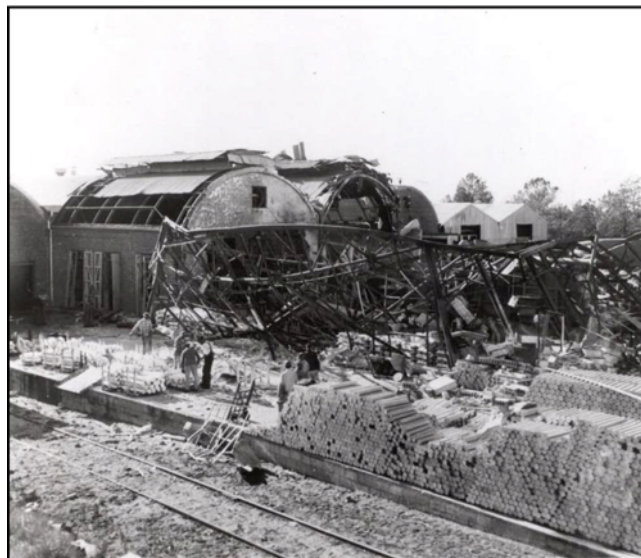
Figure 1 William L. Bonnell Company, Newnan, Georgia explosion of December 27, 1956 which was heard 15 miles away resulted in two workers killed, windows broken in residences, and tops of pine trees broken more than ½ mile away.

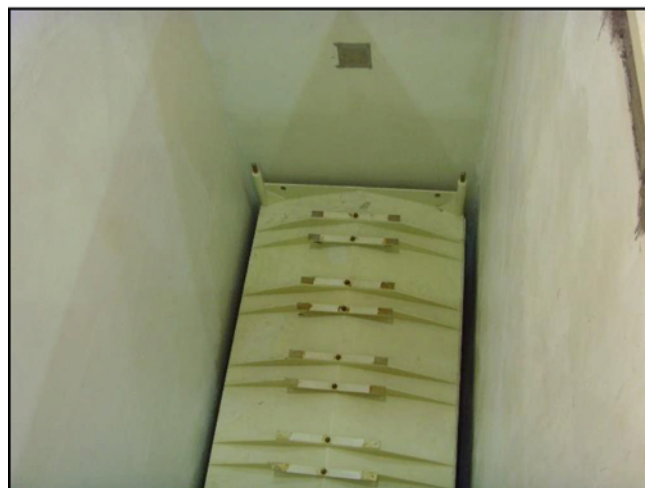
Figure 2 Stainless steel vertical casting pit built in 2012 coated with Wise Chem E-115

Water containers were constructed out of a variety of substrates during the testing (e.g., plywood, tar impregnated brick, concrete, etc). When George Long tested stainless steel water containers no explosions occurred. But “moderate” explosions were observed by Hess & Miller on stainless steel substrates. This resulted in the researchers making the unusually forceful statement “that bare stainless steel should not be used”. This recommendation seems mostly forgotten in our industry now. Some believe bare stainless substrates are safe while bare concrete and steel are dangerous in close proximity of molten metal. Hess & Miller and numerous other researchers have proven time and time again that bare concrete, bare steel **and** bare stainless steel can all generate explosions with molten metal. It is common place now to see bare stainless steel in close proximity of molten metal in cast houses. Several vertical casting pits have been constructed over the past few years out of stainless steel. Each and every stainless casting pit that was recently built was eventually coated with Wise Chem E-212-F or Wise Chem E-115.
