THE QUICK SHUT DOWN AND RESTARTING OF 291 kA PRE-BAKED POTLINE AT JSC "RUSAL SAYANOGORSK» FROM MAY TO AUGUST 2011

Victor Buzunov¹, Andrey Soldatov¹, Victor Mann², Aleksandr Pavin¹, Vasily Borisov¹, Sergey Zatepyakin¹, Evgeny Shcherbakov³, Andrey Guzenkov⁴

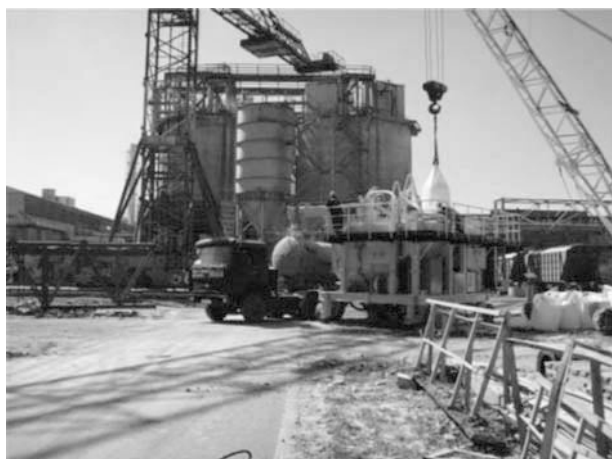
Figure 2. Raw material supply by road

On May 9, the smelter specialists were able to organize the supply of raw materials to SAZ and KhAZ by road (Figure 2).

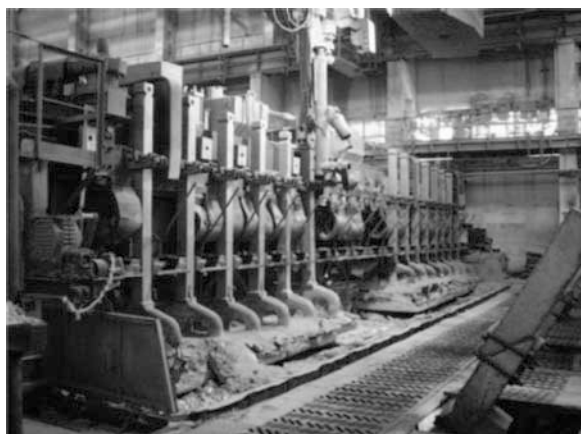
Figure 4. Butts removing

After curtailing the potroom, a schedule for cleaning the bottom from the bath and frozen aluminum was made up. First, butts were removed (Figure 4) and bath lumps were collected.

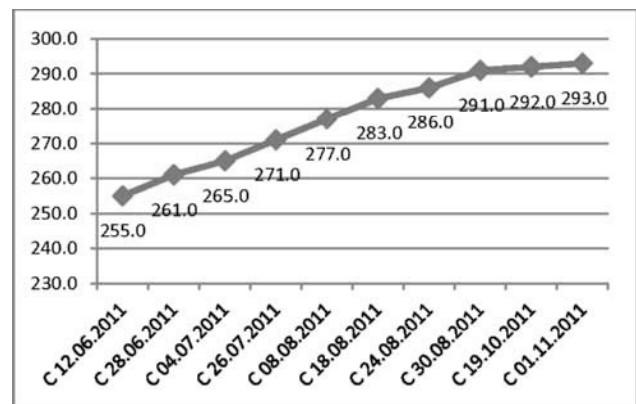
Diagram 1. Amperage, kA

After the start-up of the first group of cells, the amperage was set at 255kA. Before the start-up of the following groups of cells (2 to 4), the amperage crept up to 239kA (the pre-emergency amperage) (Diagram 1.)

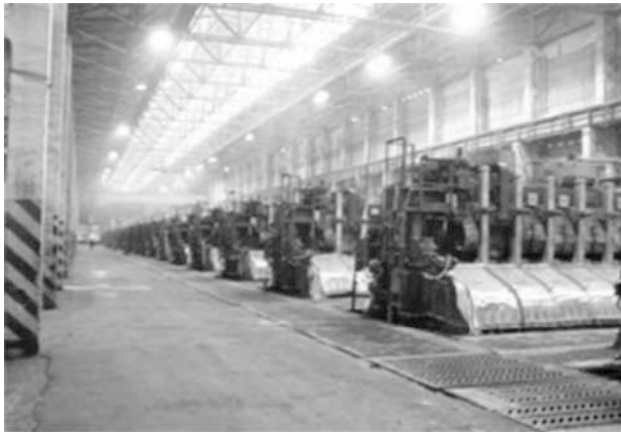
Figure 9. Potroom

On August 31, 2012, 43 restarted cells (from 139) were shut down for relining. 96 cells are still in operation (Figure 9). The cells have operated for at least 14.17 months since the restart. They continue to operate (their average service life as of August 31, 2012 is 40.67 months.)
