SLIDING WEAR BEHAVIOUR OF SQUEEZE CAST MAGNESIUM COMPOSITE AM60-9% (Al₂O₃)_f

A. Banerji¹, H. Hu¹, A.T. Alpas¹

Abstract

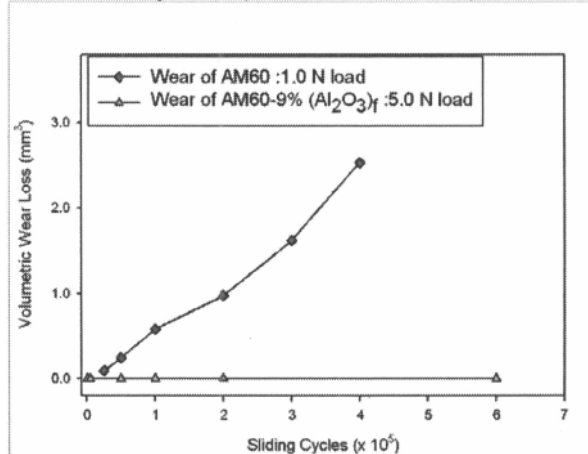
Figure 2- Volumetric wear loss vs. sliding cycles plot for AM60 alloy and AM60-9% (Al₂O₃)_f. The wear loss of the composite is 10² times lower than that of the matrix alloy. Note the wear of the composite was shown at 5.0 N and the matrix at 1.0N load.

Figure 2 shows the wear losses of AM60 alloy and AM60-9% (Al₂O₃)_f composite plotted as a function of sliding cycles. It is evident that the wear loss from the surface of AM60 alloy was 10² times higher than that of AM60-9% (Al₂O₃)_f despite the fact that the wear losses for the composite reported in this figure were measured at 5.0 N load. Figure 3a shows the SEM micrograph of wear track of the AM60 alloy at 1.0 N for 2.5×10⁴ sliding cycles and Figure 3b shows the wear track of AM60-9% (Al₂O₃)_f at 2.0 N for 6.0×10⁵ sliding cycles. The greater extent of wear (width of wear track: 0.73±0.08 mm) for the AM60 alloy at 1.0 N in comparison to the composite (width of wear track: 0.35±0.02 mm) is evident despite being worn at a higher load and for longer sliding cycles.

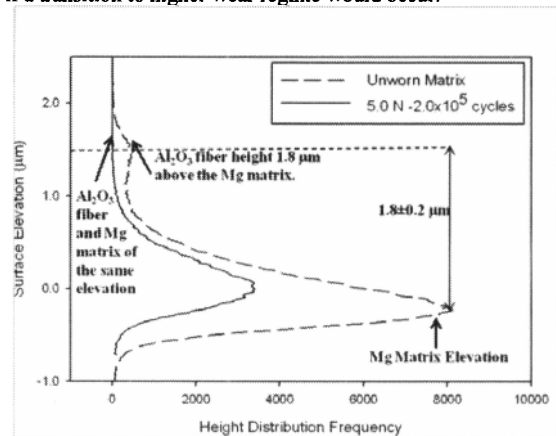
Figure 7- Histogram showing the height differences between the magnesium matrix and the alumina fibres for the unworn surface and also the worn surface after 2×10^5 cycles at 5.0 N load. For the unworn surface the average height difference is $1.8 \mu m$ whereas for the worn surface the height of the matrix and the fibres are the same after 2×10^5 cycles at 5.0 N load.

fractured and buried into the matrix during sliding contact. The difference in elevation of the Mg matrix and the Al₂O₃ fibres was quantified by optical profilometry measurements from which histogram showing the distribution (frequency) of Mg matrix and Al₂O₃ fibre was plotted. The second Gaussian peak, with higher frequency represents the Mg matrix. This peak serves as the reference point for the other Gaussian peak which represents the Al₂O₃ fibre elevation with respect to the matrix.
